RESERVE ANALYSIS REPORT

CBS Sample Owners Association

Full Study with Site Visit

January 1, 2021

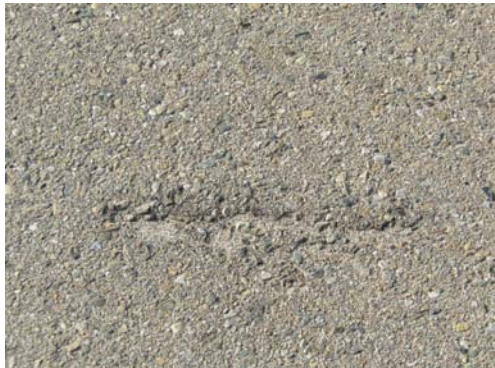
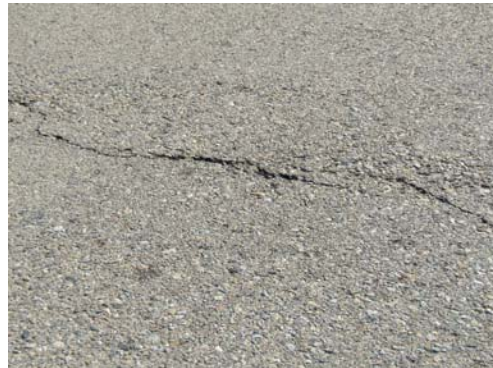
Asphalt - Slurry Seal & Repair - 2022

This component is for the preparation of the asphalt and application of the slurry seal coat to the asphalt. A seal coat is a thin liquid application which consists of a slow setting asphalt chemical emulsion mixed with fillers, water and various additives. This provides a sealant to the top of the asphalt, preventing water from penetrating the surface and providing a limited amount of protection from the sun. This component includes crack fill, skin patching, minor dig out & fill, etc. If a second coat is desired the cost is generally 10% to 20% higher. Cracks 1/4" or wider should be filled when observed. The observed condition was fair with several small areas of erosion and cracks noted.

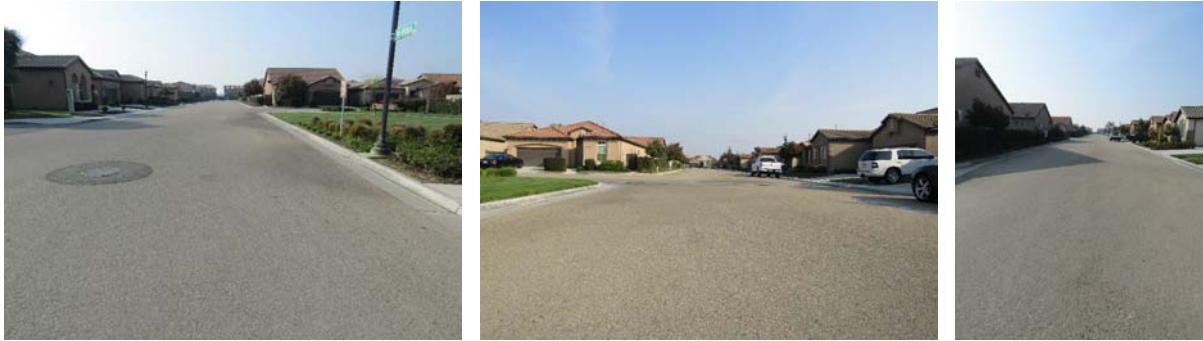
Asphalt Overlay & Replacement continued...

There are many factors which can cause damage to asphalt. In most cases it's time which has simply "worn out" the asphalt. Of course weather also plays a major part in deterioration, especially on asphalt that has not been properly maintained. Motor oil, gasoline, and other household chemicals also break down the asphalt if they are left to soak in. This component is to apply a petromat overlay on top of the existing asphalt surface along with 1-1/2" of new hot mix asphalt. Generally this includes edge grinding, utility box extensions and filling potholes. The observed condition of the roadway asphalt was good with minimal areas of wear noted.

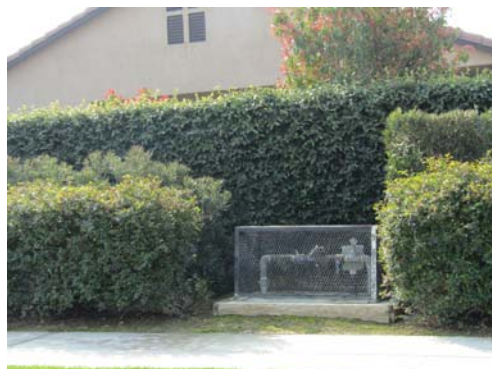
This component covers the replacement of the backflow preventers. They appear to be in fair condition, enclosed in metal mesh crates.

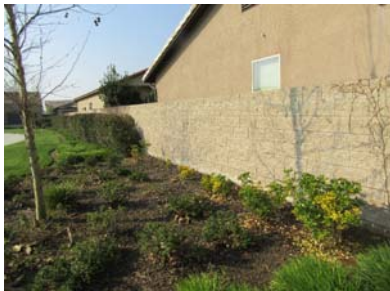
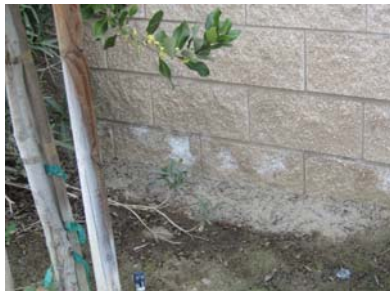
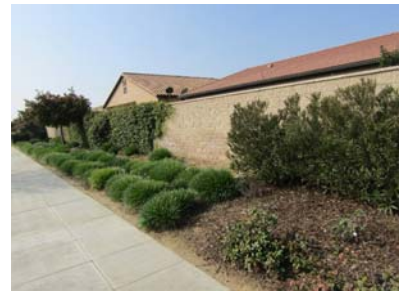
Block Wall & Masonry - Repairs - 2022

The development is surrounded by 6' concrete block wall on the north and east sides, as well as along all the common landscaping throughout the development and the stone pillars and entry monument. This wall appeared to be in good condition without any sign of defect, aside from some minor efflorescence and discoloration due to sprayback from the sprinklers. This reserve component is for the maintenance and repair of the wall and stone only, as the overall component will typically last the life of the development. Maintenance may include mechanical and/or chemical cleaning, efflorescence removal, graffiti removal, sealing, etc.

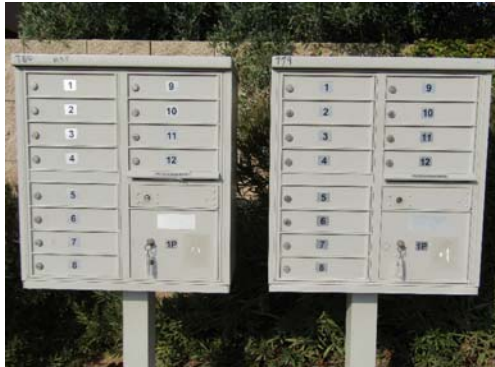
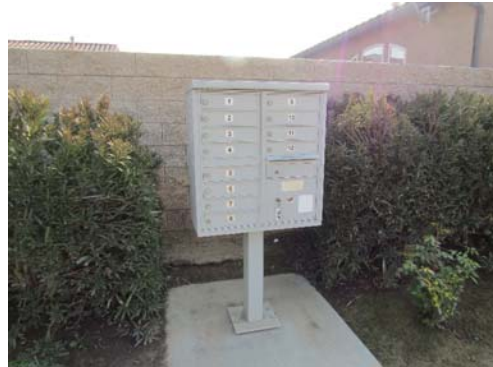
This is to replace the mailbox clusters containing 12 boxes, 1 parcel box, and a drop box (14 doors total). Locks and hinges should be lubricated seasonally, as needed. At the time of inspection, the mailboxes appeared to be in good condition, with typical signs of aging but no sign of minor surface rust, dents, excessive wear, warping, or vandalism.

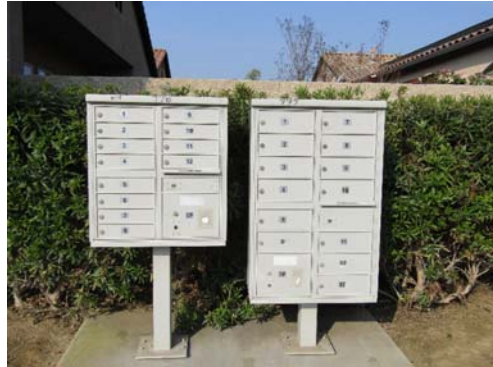
Cluster Mailboxes - 13 Units continued...

This is to replace the mailbox clusters containing 13 boxes, 1 parcel box, and a drop box (15 doors total). Locks and hinges should be lubricated seasonally, as needed. At the time of inspection, the mailboxes appeared to be in good condition, with typical signs of aging but no sign of minor surface rust, dents, excessive wear, warping, or vandalism.

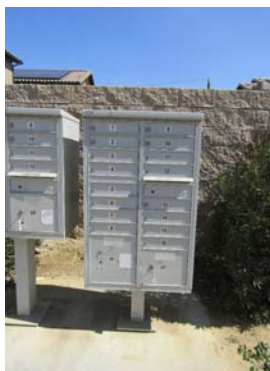
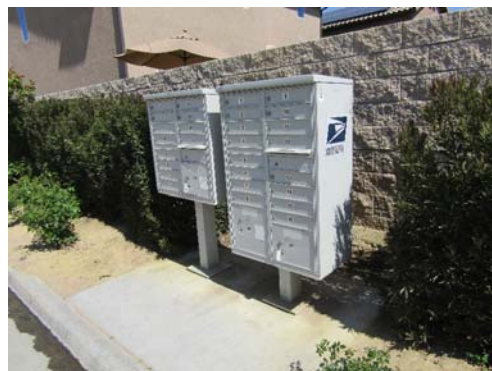
This is to replace the mailbox clusters containing 16 boxes, 2 parcel boxes, and a drop box (19 doors total). Locks and hinges should be lubricated seasonally, as needed. At the time of inspection, the mailboxes appeared to be in good condition, with typical signs of aging but no

sign of minor surface rust, dents, excessive wear, warping, or vandalism.

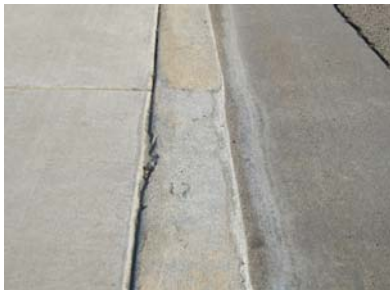
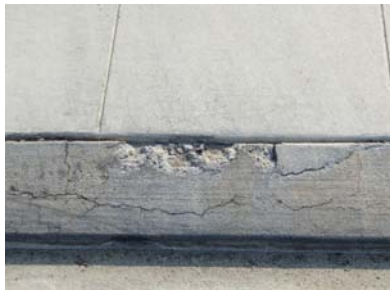
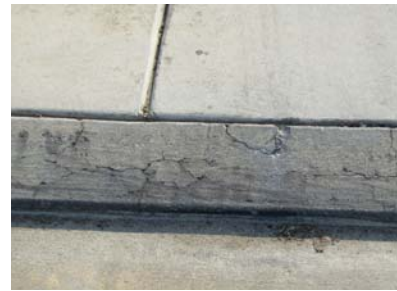
This component covers the maintenance and repair of the curb and gutter throughout the development. The curb and gutter appeared to be in fair condition with some areas of chipping and cracking. This component should last the life of the development with proper maintenance. Such maintenance may include crack fill, grinding, efflorescence removal, sealing, etc. We estimate 2% will require repair every 5 years.

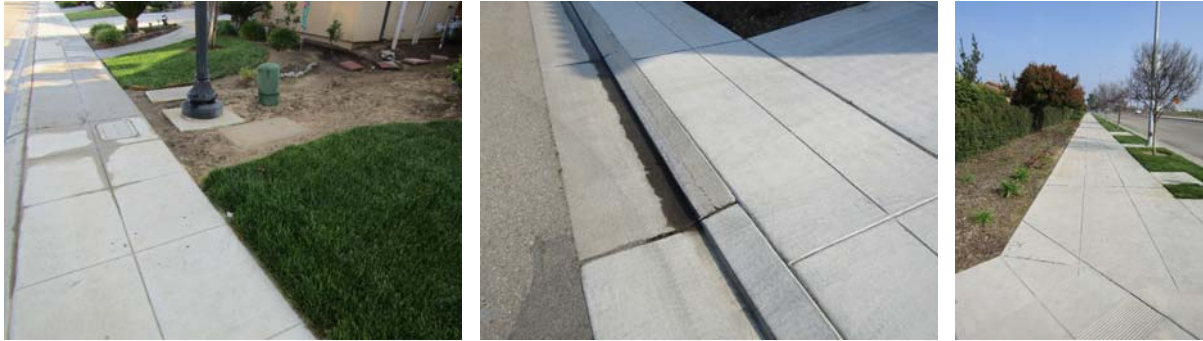
Concrete Sidewalks continued...

This component covers the repair of the concrete walkways within the development and along Church and Fowler Avenues. Annual inspection and repairs may be recommended and necessary to ensure the safety of its members by correcting any elevation changes and trip hazards that the association may be held liable for. Cracks in concrete can be unsightly and create moisture problems. Repairing such cracks is vital in order to keep moisture out. The concrete sidewalks' overall appearance is in good condition with some areas that have some noticeable cracks.

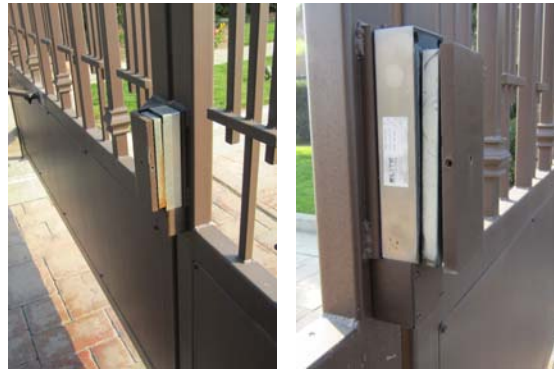
Electromagnetic Locks continued...

The magnetic gate locks appeared in fair condition but were noted to be non-functioning.

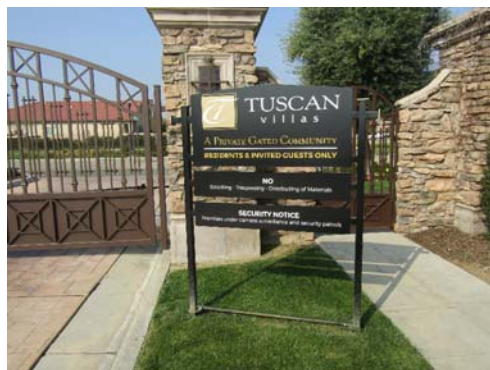
This component is for the replacement of the custom sign at the entry on Fowler Avenue. Records indicate the sign was manufactured and installed in June, 2016.

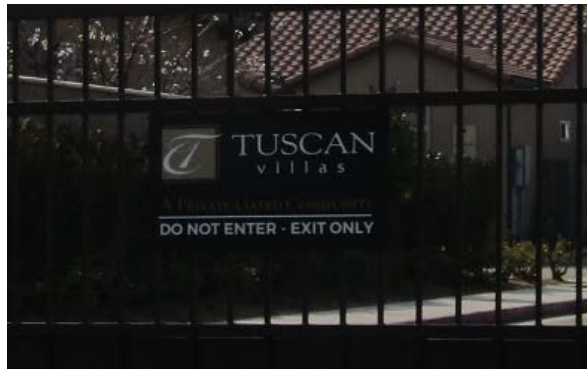
This component is for the replacement of the custom sign at the exit on Church Avenue. Records indicate the sign was manufactured and installed in June, 2016.

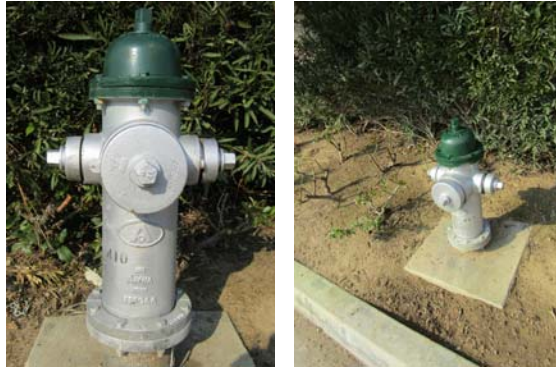
Fire Hydrants - Painting continued...

This component is for the painting of the fire hydrants. This is an as-needed item when noticeably needed or requested by the fire inspector. Currently, the paint on the fire hydrants appeared to be in good condition. Painting is not recommended at this time.

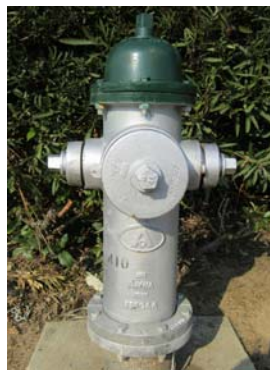
Fire Hydrants - Replacement - 2047

The fire hydrants located throughout the development appeared to be in good condition. This component is for the complete replacement of the hydrants.

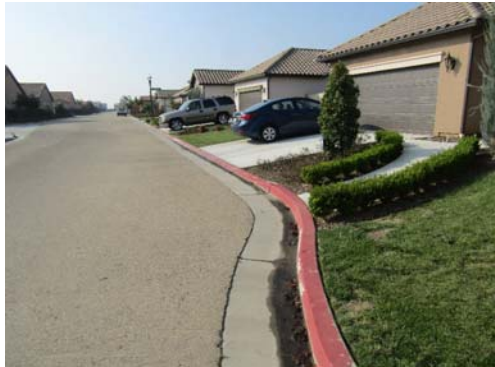
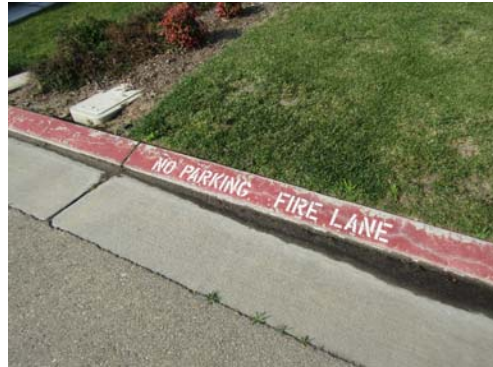
The red painted curb is faded and chipping. Painting is recommended.

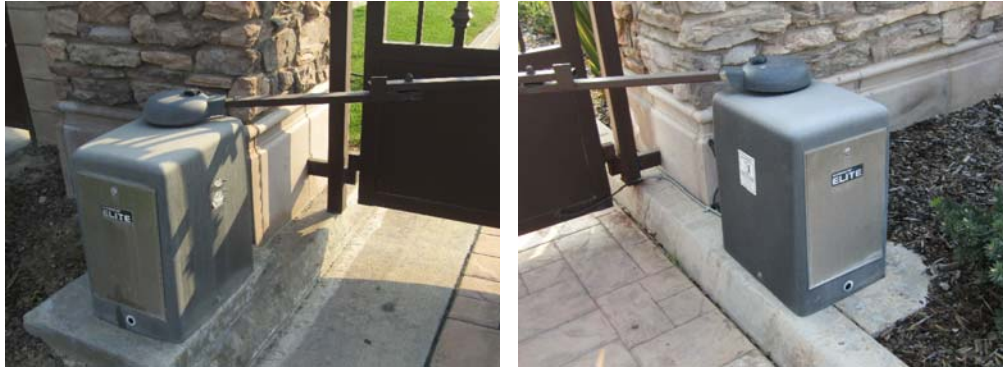
Gate Operators continued...

This component provides for the replacement of the Chamberlain Elite CSW200ULDC3 gate motor/operators, located at the entry gate, the exit gate and the emergency vehicle access gate. The operator at the emergency access gate was behind a locked gate and was not visually inspected. A gate operator is a mechanical device used to open and close the entry and exit gate. That gate is programmed to open and close with an access entry system and can be opened manually if necessary. A swing arm operator, which is a box that sits off to the side, has an arm extending to the gate. A slide gate operator slides the gate to either side. The gate operators appeared to be in good condition. There was no noticeable rusting on the mechanism. The function of these operators was observed and was noted to function correctly without any sign of defect. Regular maintenance is recommended to prevent premature failure of the component.

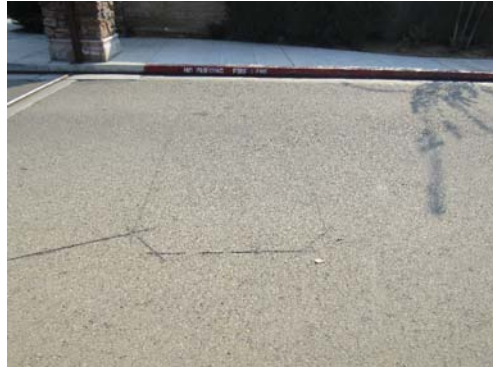
Gate Sensor Loops continued...

This is for the replacement of the underground sensor loops and the pulling of new wire harnesses. The current harnesses were functioning properly at time of inspection. If possible, loop replacement should be scheduled to coincide with paving repairs or gate operator replacement.

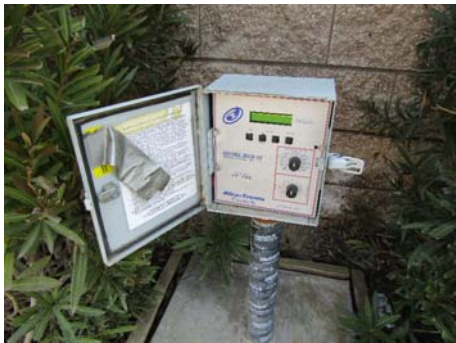
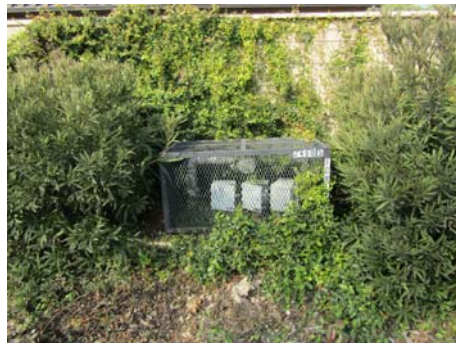
The Alex-Tronix BCS-10 irrigation system controllers appeared in varying condition with no signs of operational problems. Irrigation controllers usually have a normal useful life ranging from 8 to 15 years depending on unit type and the environmental conditions they are subject

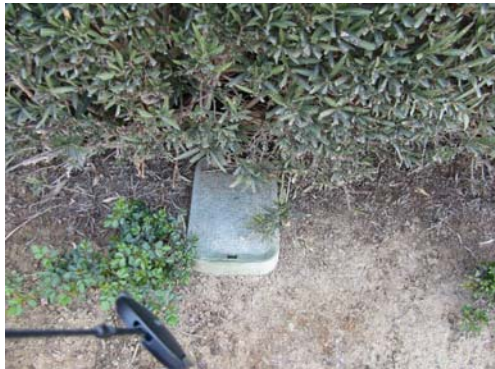
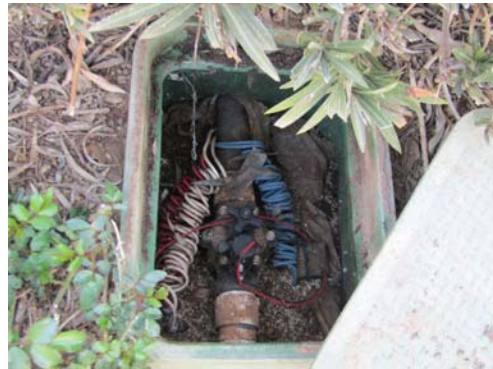
The irrigation valves were examined during the onsite inspection. All were covered by in-ground valve boxes and appeared to be in fair condition.

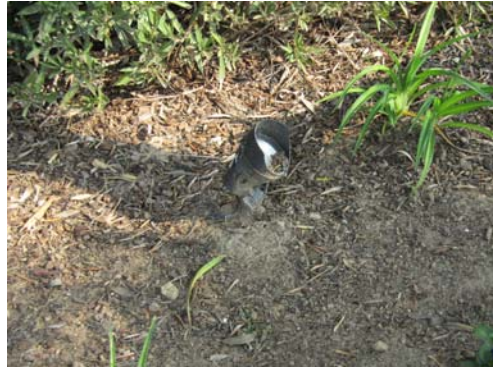
Landscape Lighting continued...

This item is for the replacement of the directional accent landscape lights, located at the Fowler Avenue entry. The lights appeared to be in good condition. Their operation was not observed. Price and date in service provided by an invoice from Albright Electric. Bulbs are an operating expense and should be replaced as noticed.

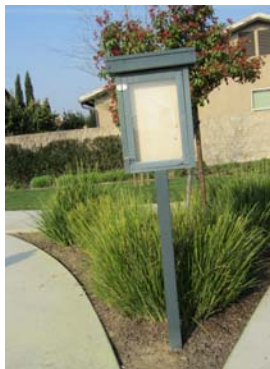
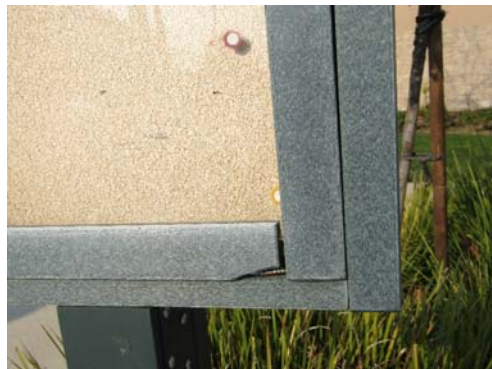
This component covers the replacement of the post-mounted corkboard message center located in the park. At time of inspection, it appeared in fair condition with fading and minor damage noted to the bottom of the door.

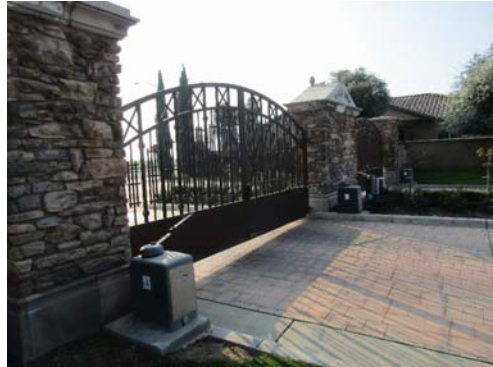
Metal Vehicle Gates continued...

This component is for the replacement of the decorative metal vehicle gates along Fowler Avenue. The gates and hinges appeared to be in good condition without any sign of damage or rust. With proper maintenance, the useful life could be greatly extended. Painting is provided for within another component.

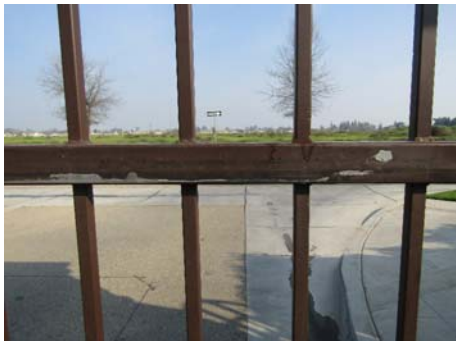
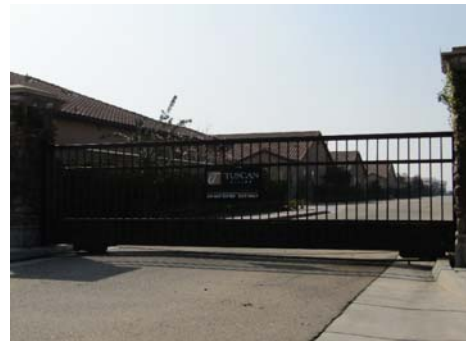
This is to prepare, power wash, sand, scrape, spot prime and paint the metal vehicle, pedestrian and mechanical access gates. To ensure the metal achieves its full useful life, it should be painted as recommended. The paint on the gates is in good condition. There is one area of

damage noted on the emergency vehicle access gate along Church Avenue. Painting is used to prolong the remaining life of metals because this can prevent rust and corrosion.

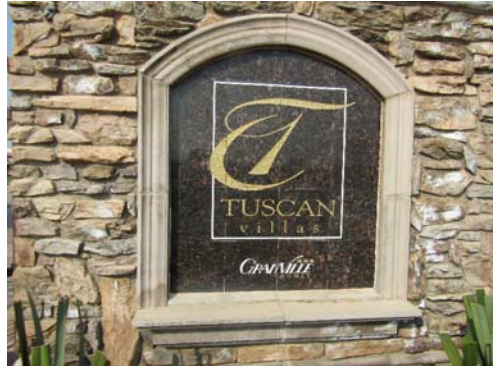
This component covers the replacement of the granite monument sign located at the Fowler Avenue entry. It appeared to be in good condition with no sign of damage. Efflorescence is noted on the stone surrounding the sign. This has been addressed within another component.

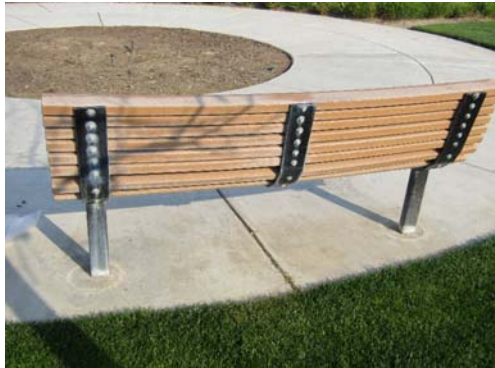
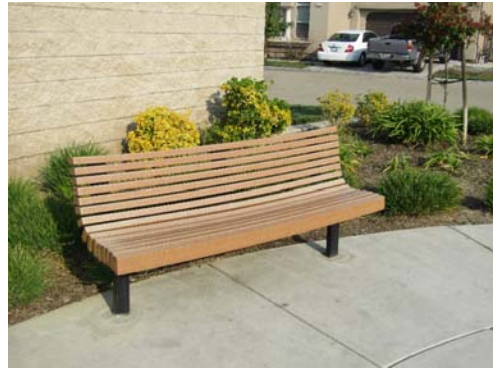
This component covers the replacement of the in-ground mounted recycled plastic park benches located in the park area. They appeared to be in good condition with no signs of damage or excessive wear.

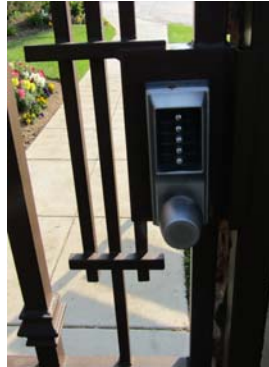
Pedestrian Gate Locks continued...

This component is for the replacement of the Simplex EE1000 double-sided gate locks. They appeared to be in good condition. Their function was not observed.

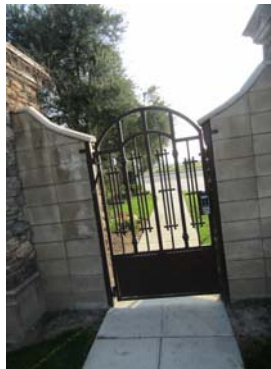
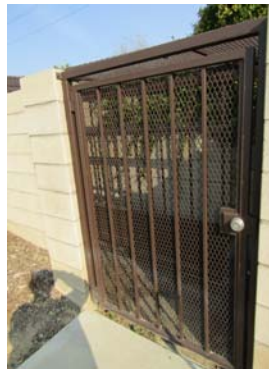
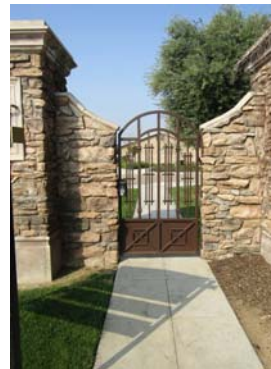
This component is for the replacement of the metal pedestrian gates. The gates appeared to be in good condition without any sign of damage or rust. With proper maintenance, the useful life could be greatly extended. Painting is provided for within another component.

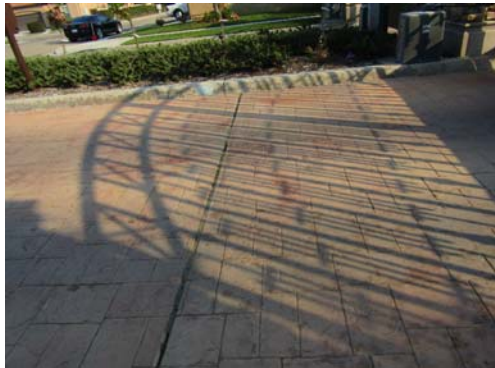
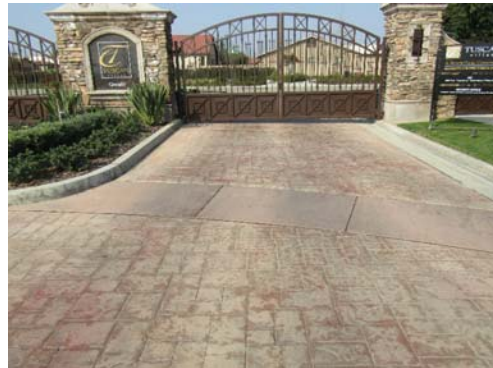
The stamped concrete paving at the entrance of the development appeared to be in fair condition with cracking noted throughout. The life of this component will exceed the scope of this 30 year study. This component should last the life of the development with proper maintenance. Periodic maintenance may include mechanical and/or chemical cleaning, efflorescence removal, sealing, grinding, etc. We estimate 5% of the concrete will require repairs every 5 years.

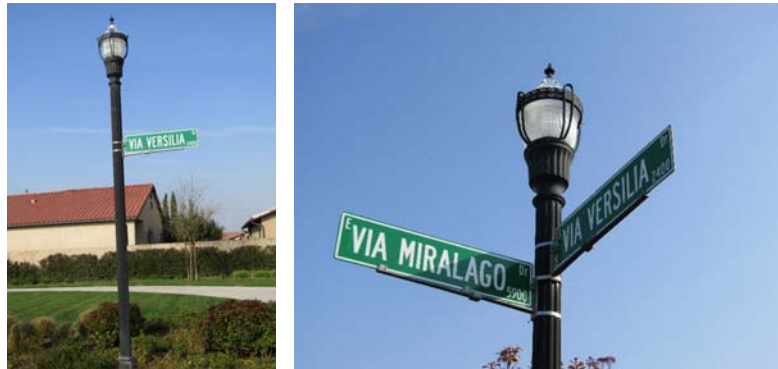
Street Lights continued...

The GM-8036 exterior light fixtures located throughout the development appeared to be in good condition with some signs of wear or damage noted. Bulbs are an operating expense and should be replaced as noticed.

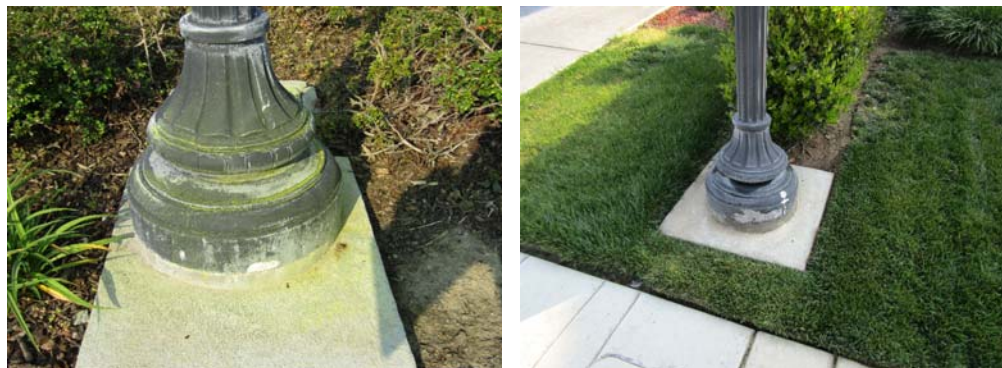
This component covers the painting of the street light posts. There are areas of noticeable wear. Painting is used to prolong the remaining life of metals because this can prevent rust and corrosion. The painting preparation should include power washing, scraping and repair if needed.

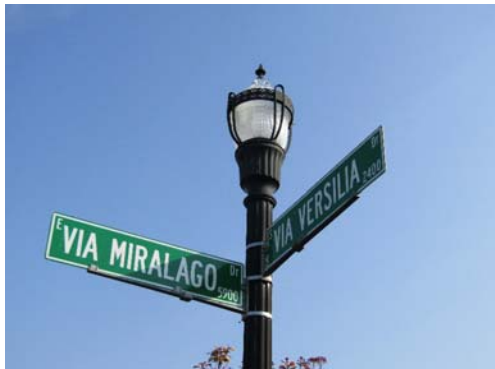
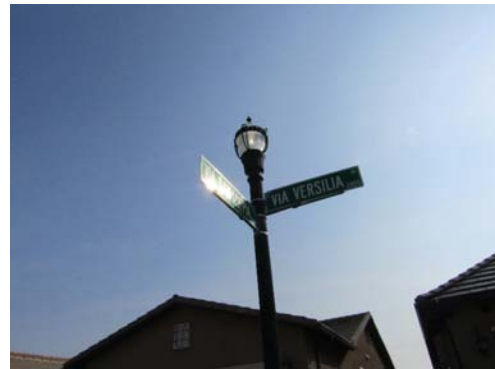
This component covers the replacement of the street signs throughout the development. They appeared to be in good condition.

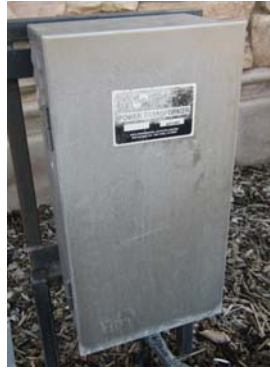
Transformer continued...

The lighting is controlled by a Vista model MT1200 power transformer. This item appeared to be in fair condition. The functionality was not observed. This component is for the replacement and reinstallation of the item.

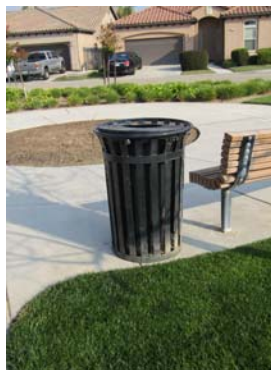
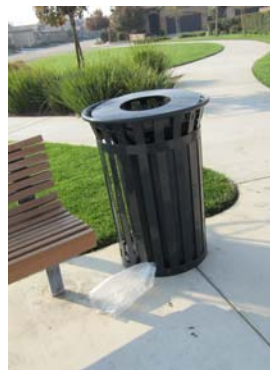
This component is for the Cassidy style trash receptacle located in the park. It appeared to be in good condition.

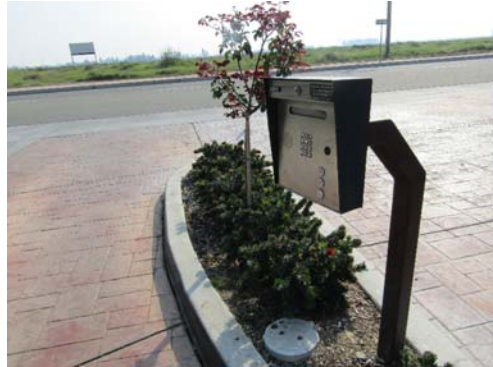
Vehicle Entrance - Keypad/Intercom continued...

The entry keypad is a DoorKing DKS model 1834. It appeared to be in fair condition without any sign of damage or malfunction. Typically, if the keys show signs of wear or sticking, the key code can be changed to less frequently used numbers to extend the life of the component and provide more equal wear.

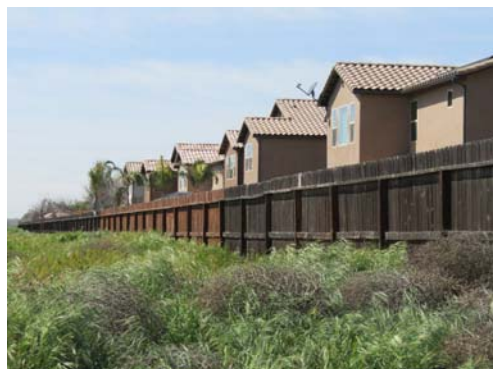
This component is for the replacement of the 6' wood fencing along the south perimeter only. According to the Covenants, Conditions and Restrictions, the Association is "responsible for repair, maintenance, or replacement of the exterior portions of the the perimeter walls or
