RESERVE ANALYSIS REPORT

CBS Sample Owners Association

Full Study with Site Visit

February 5, 2022

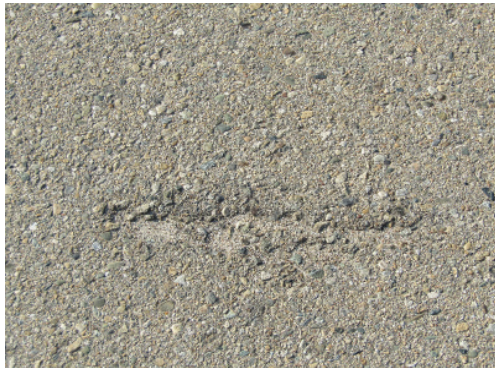
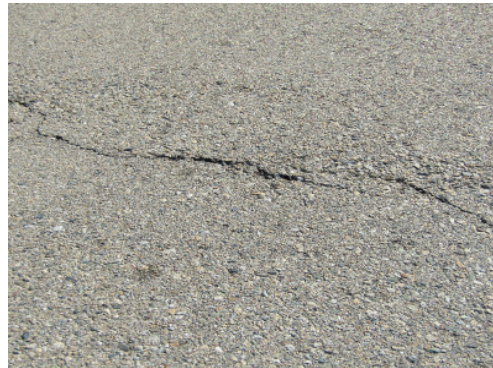
This component is for the preparation of the asphalt and application of the slurry seal coat to the asphalt. A seal coat is a thin liquid application which consists of a slow setting asphalt chemical emulsion mixed with fillers, water and various additives. This provides a sealant to the top of the asphalt, preventing water from penetrating the surface and providing a limited amount of protection from the sun. This component includes crack fill, skin patching, minor dig out & fill, etc. If a second coat is desired the cost is generally 10% to 20% higher. Cracks 1/4" or wider should be filled when observed. The observed condition was fair with several small areas of erosion and cracks noted.

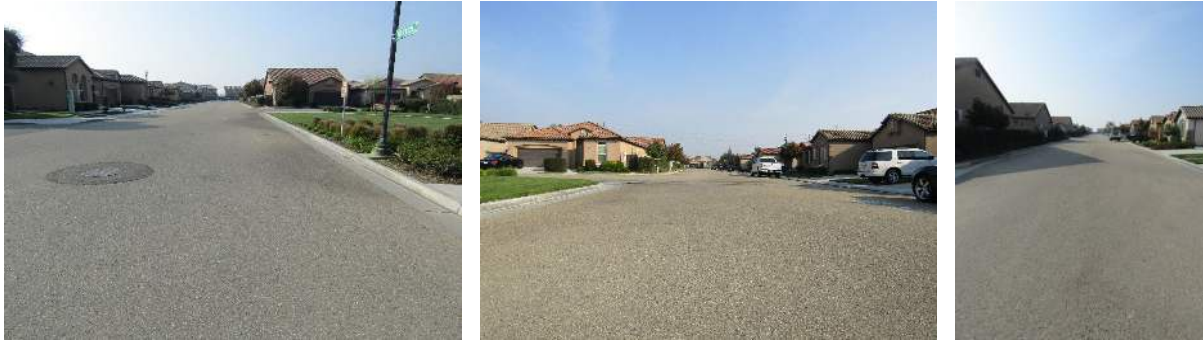
Asphalt Overlay & Replacement continued...

There are many factors which can cause damage to asphalt. In most cases it's time which has simply "worn out" the asphalt. Of course weather also plays a major part in deterioration, especially on asphalt that has not been properly maintained. Motor oil, gasoline, and other household chemicals also break down the asphalt if they are left to soak in. This component is to apply a petromat overlay on top of the existing asphalt surface along with 1-1/2" of new hot mix asphalt. Generally this includes edge grinding, utility box extensions and filling potholes. The observed condition of the roadway asphalt was good with minimal areas of wear noted.

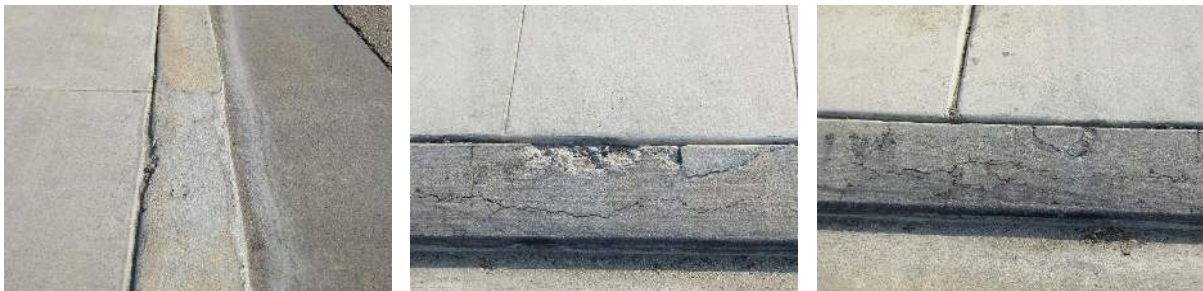
Concrete Curb & Gutter continued...

This component covers the maintenance and repair of the curb and gutter throughout the development. The curb and gutter appeared to be in fair condition with some areas of chipping and cracking. This component should last the life of the development with proper maintenance. Such maintenance may include crack fill, grinding, efflorescence removal, sealing, etc. We estimate 2% will require repair every 5 years.

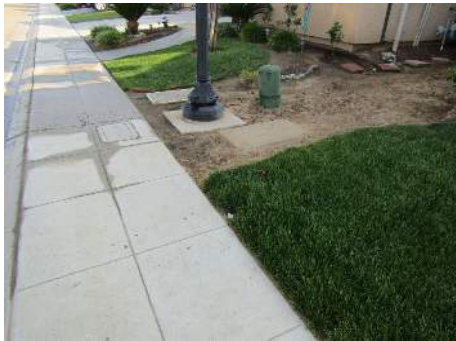
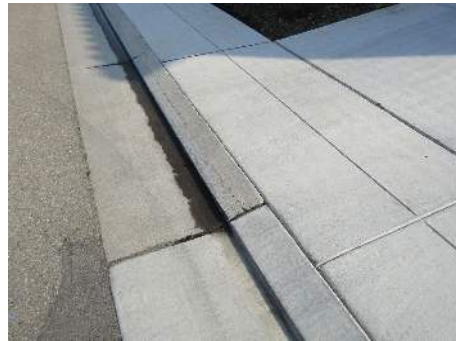
This component covers the repair of the concrete walkways within the development and along Church and Fowler Avenues. Annual inspection and repairs may be recommended and necessary to ensure the safety of its members by correcting any elevation changes and trip hazards that the association may be held liable for. Cracks in concrete can be unsightly and create moisture problems. Repairing such cracks is vital in order to keep moisture out. The concrete sidewalks' overall appearance is in good condition with some areas that have some noticeable cracks.

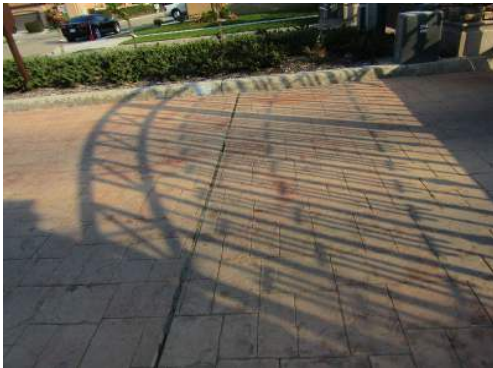
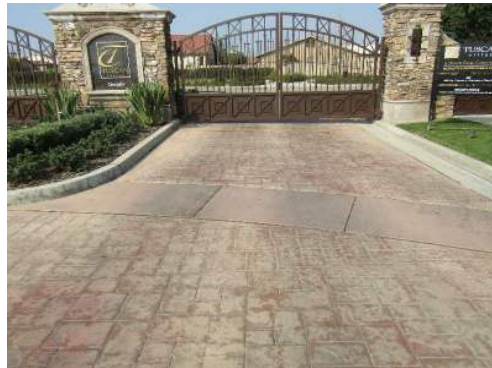
The stamped concrete paving at the entrance of the development appeared to be in fair condition with cracking noted throughout. The life of this component will exceed the scope of this 30 year study. This component should last the life of the development with proper maintenance. Periodic maintenance may include mechanical and/or chemical cleaning, efflorescence removal, sealing, grinding, etc. We estimate 5% of the concrete will require repairs every 5 years.

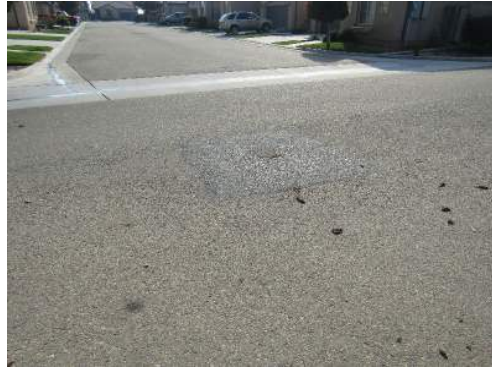
Valley Gutter continued...

There is approximately 319' of concrete valley gutter in the development. The component is for the repair and replacement. The current condition of the concrete was good. Periodic maintenance may include efflorescence removal, sealing, grinding, crack fill, or replacement. We estimate 5% will require repair every 5 years.

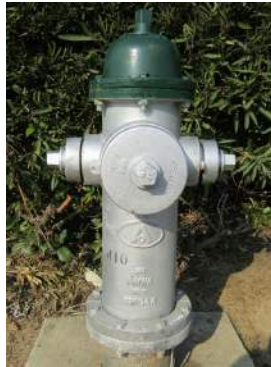
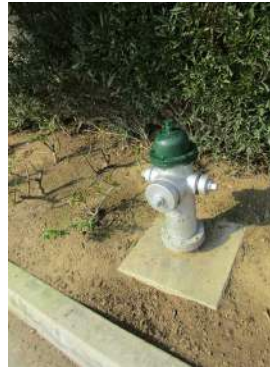
This component is for the painting of the fire hydrants. This is an as-needed item when noticeably needed or requested by the fire inspector. Currently, the paint on the fire hydrants appeared to be in good condition. Painting is not recommended at this time.

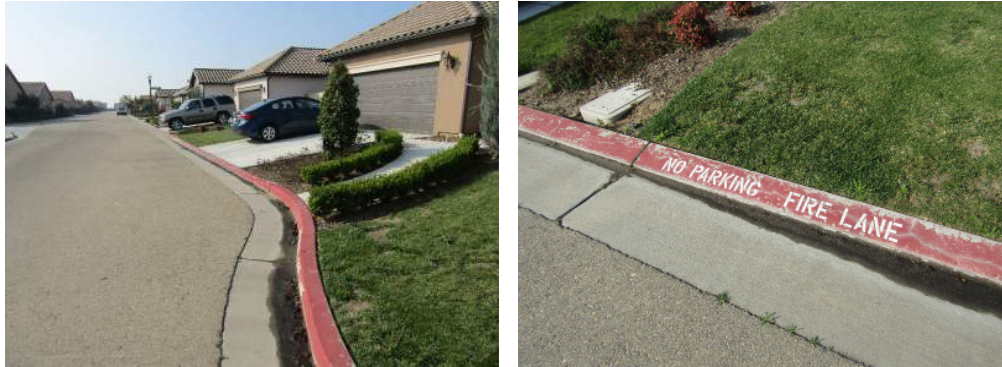
Fire Lane continued...

The red painted curb is faded and chipping. Painting is recommended.

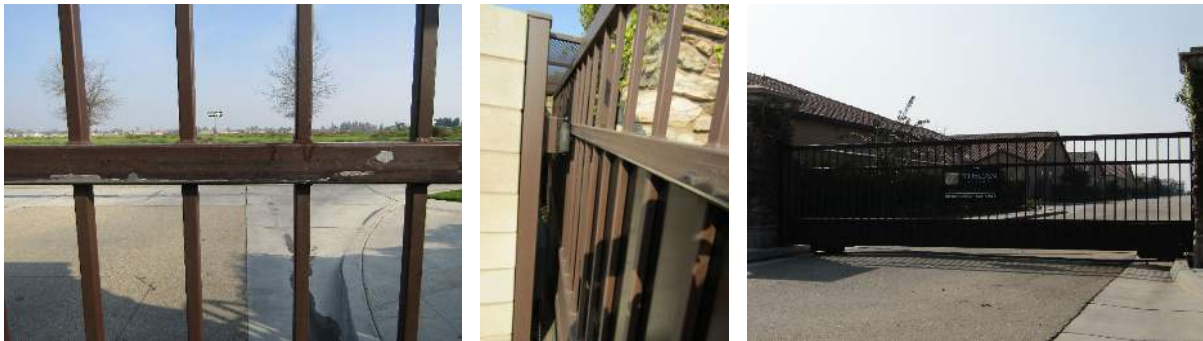
This is to prepare, power wash, sand, scrape, spot prime and paint the metal vehicle, pedestrian and mechanical access gates. To ensure the metal achieves its full useful life, it should be painted as recommended. The paint on the gates is in good condition. There is one area of damage noted on the emergency vehicle access gate along Church Avenue. Painting is used to prolong the remaining life of metals because this can prevent rust and corrosion.

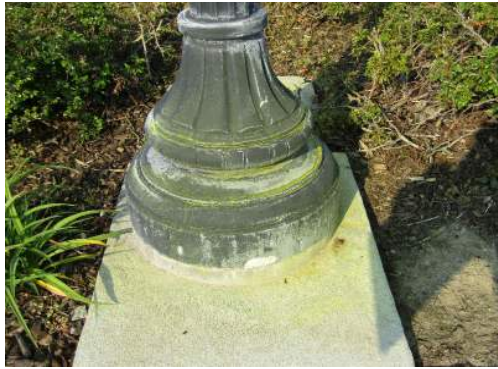
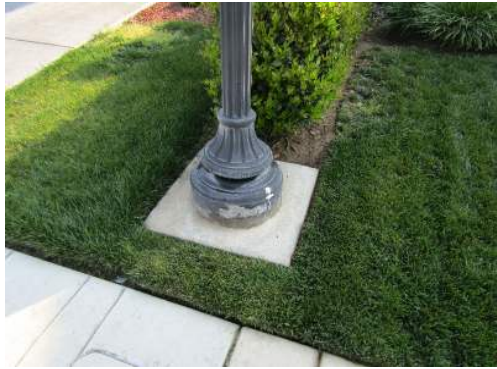
This component covers the painting of the street light posts. There are areas of noticeable wear. Painting is used to prolong the remaining life of metals because this can prevent rust and corrosion. The painting preparation should include power washing, scraping and repair if needed.

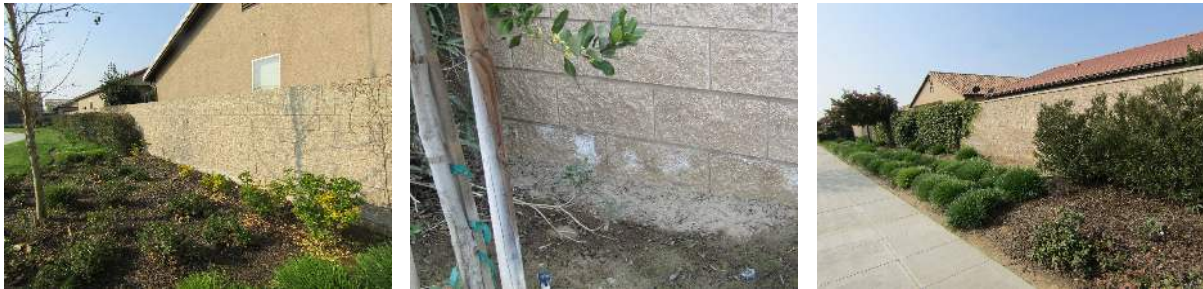
The development is surrounded by 6' concrete block wall on the north and east sides, as well as along all the common landscaping throughout the development and the stone pillars and entry monument. This wall appeared to be in good condition without any sign of defect, aside from some minor efflorescence and discoloration due to sprayback from the sprinklers. This reserve component is for the maintenance and repair of the wall and stone only, as the overall component will typically last the life of the development. Maintenance may include mechanical and/or chemical cleaning, efflorescence removal, graffiti removal, sealing, etc.

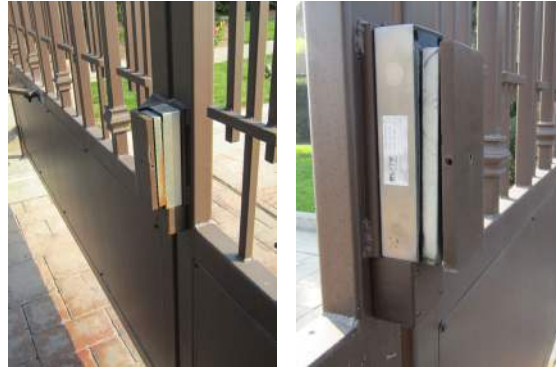
Electromagnetic Locks continued...

The magnetic gate locks appeared in fair condition but were noted to be non-functioning.

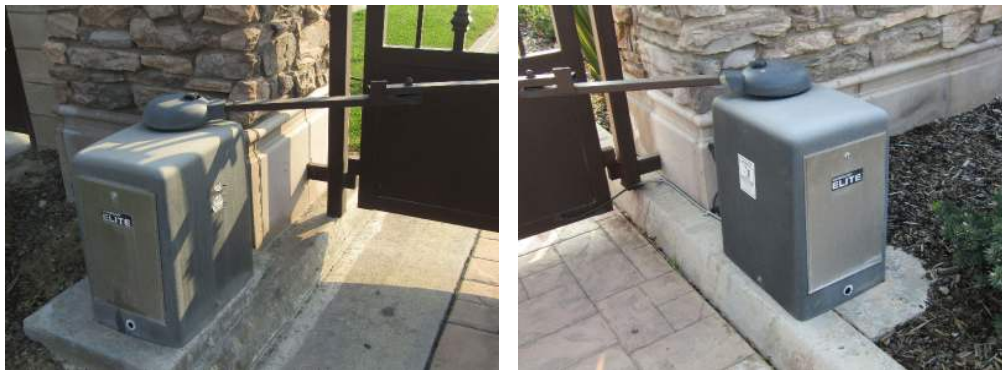
This component provides for the replacement of the Chamberlain Elite CSW200ULDC3 gate motor/operators, located at the entry gate, the exit gate and the emergency vehicle access gate. The operator at the emergency access gate was behind a locked gate and was not visually inspected. A gate operator is a mechanical device used to open and close the entry and exit gate. That gate is programmed to open and close with an access entry system and can be opened manually if necessary. A swing arm operator, which is a box that sits off to the side,

has an arm extending to the gate. A slide gate operator slides the gate to either side. The gate operators appeared to be in good condition. There was no noticeable rusting on the mechanism. The function of these operators was observed and was noted to function correctly without any sign of defect. Regular maintenance is recommended to prevent premature failure of the component.

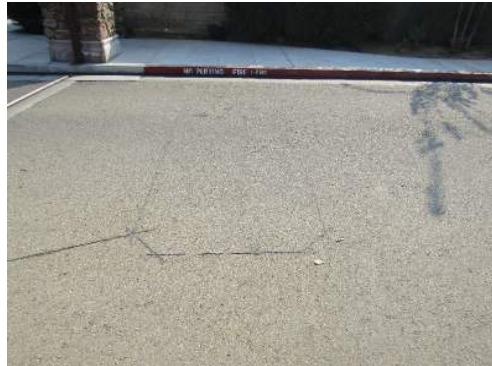
This is for the replacement of the underground sensor loops and the pulling of new wire harnesses. The current harnesses were functioning properly at time of inspection. If possible, loop replacement should be scheduled to coincide with paving repairs or gate operator replacement.

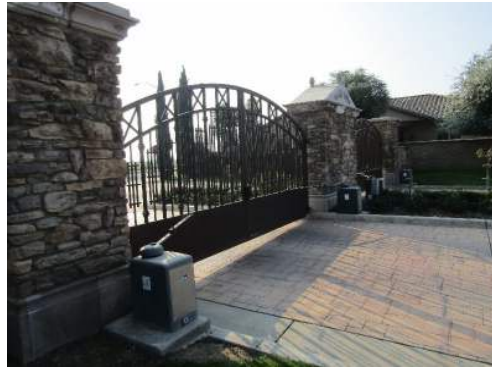
This component is for the replacement of the decorative metal vehicle gates along Fowler Avenue. The gates and hinges appeared to be in good condition without any sign of damage or rust. With proper maintenance, the useful life could be greatly extended. Painting is provided for within another component.

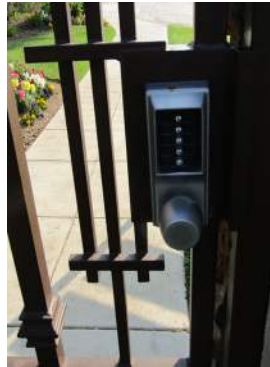
This component is for the replacement of the Simplex EE1000 double-sided gate locks. They appeared to be in good condition. Their function was not observed.

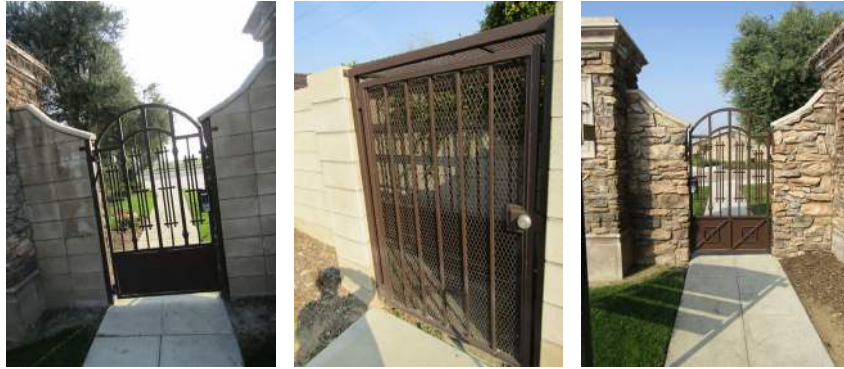
Pedestrian Gates continued...

This component is for the replacement of the metal pedestrian gates. The gates appeared to be in good condition without any sign of damage or rust. With proper maintenance, the useful life could be greatly extended. Painting is provided for within another component.

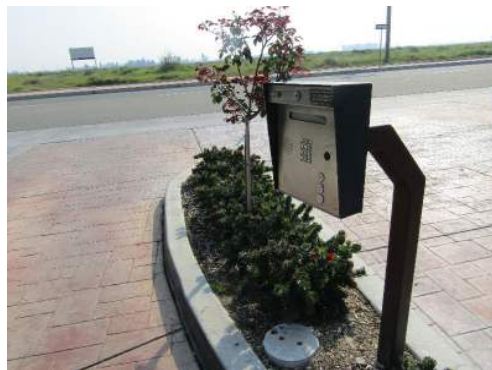
The entry keypad is a DoorKing DKS model 1834. It appeared to be in fair condition without any sign of damage or malfunction. Typically, if the keys show signs of wear or sticking, the key code can be changed to less frequently used numbers to extend the life of the component and provide more equal wear.

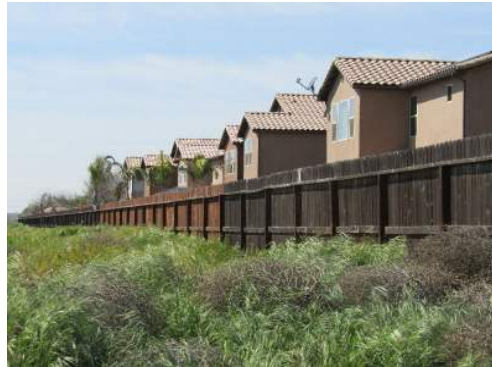
This component is for the replacement of the 6' wood fencing along the south perimeter only. According to the Covenants, Conditions and Restrictions, the Association is "responsible for repair, maintenance, or replacement of the exterior portions of the the perimeter walls or fences adjacent to public streets or open space surrounding the project." The previous reserve study included the wood fencing along the west perimeter as well, but that currently abuts another subdivision and is no longer Association maintenance area. The wood fencing appears to be in fair condition with some signs of aging noted.

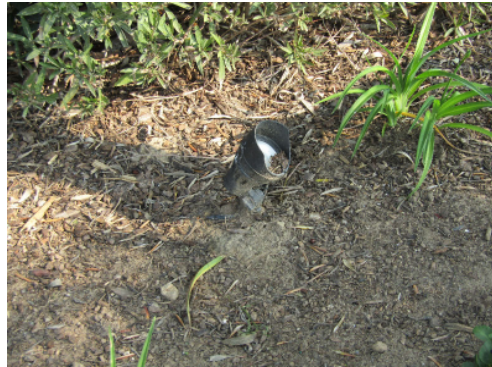
This item is for the replacement of the directional accent landscape lights, located at the Fowler Avenue entry. The lights appeared to be in good condition. Their operation was not observed. Price and date in service provided by an invoice from Albright Electric. Bulbs are an operating expense and should be replaced as noticed.

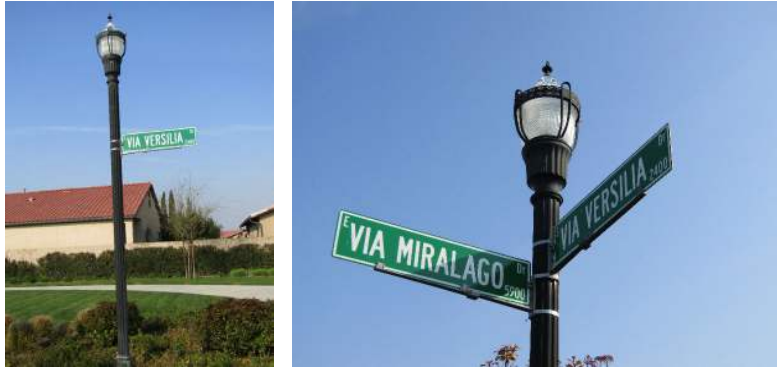
Street Lights continued...

The GM-8036 exterior light fixtures located throughout the development appeared to be in good condition with some signs of wear or damage noted. Bulbs are an operating expense and should be replaced as noticed.

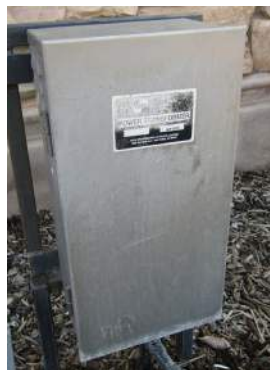
The lighting is controlled by a Vista model MT1200 power transformer. This item appeared to be in fair condition. The functionality was not observed. This component is for the replacement and reinstallation of the item.

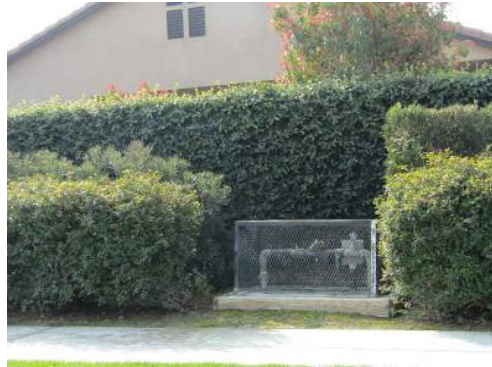
This component covers the replacement of the backflow preventers. They appear to be in fair condition, enclosed in metal mesh crates.

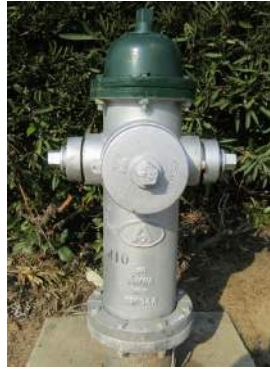
Fire Hydrants - Replacement continued...

The fire hydrants located throughout the development appeared to be in good condition. This component is for the complete replacement of the hydrants.

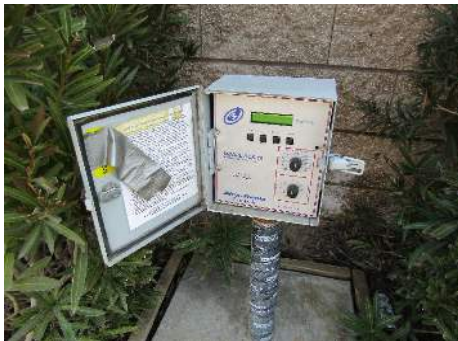
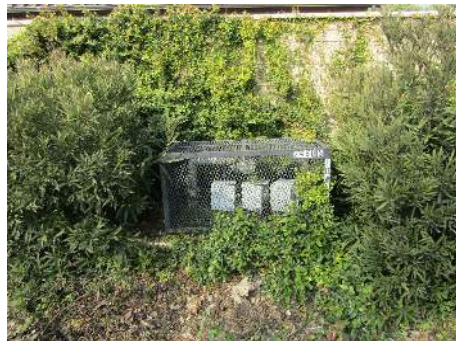
The Alex-Tronix BCS-10 irrigation system controllers appeared in varying condition with no signs of operational problems. Irrigation controllers usually have a normal useful life ranging from 8 to 15 years depending on unit type and the environmental conditions they are subject to. There is no periodic maintenance required with most name brand irrigation controllers.

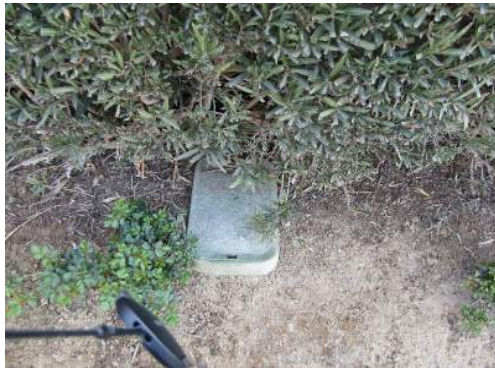
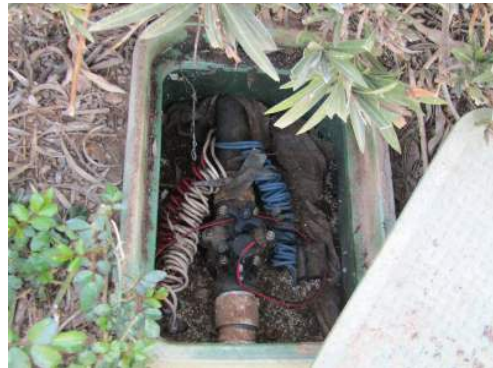
The irrigation valves were examined during the onsite inspection. All were covered by in-ground valve boxes and appeared to be in fair condition.

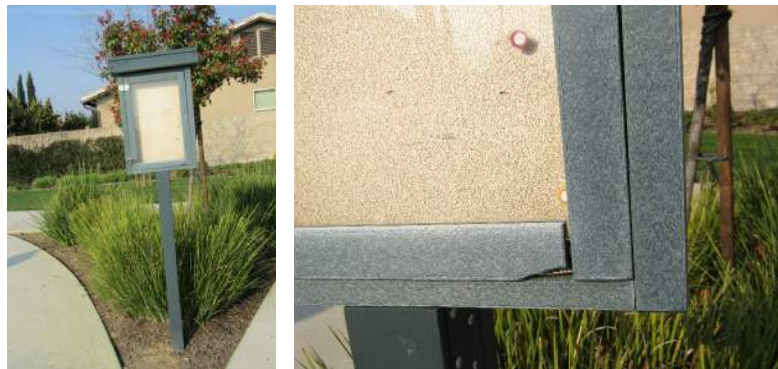
This component covers the replacement of the post-mounted corkboard message center located

in the park. At time of inspection, it appeared in fair condition with fading and minor damage noted to the bottom of the door.

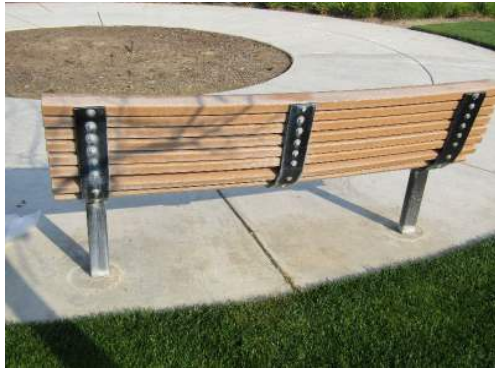
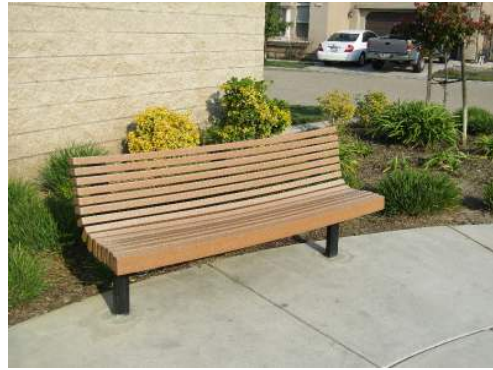
This component covers the replacement of the in-ground mounted recycled plastic park benches located in the park area. They appeared to be in good condition with no signs of damage or excessive wear.

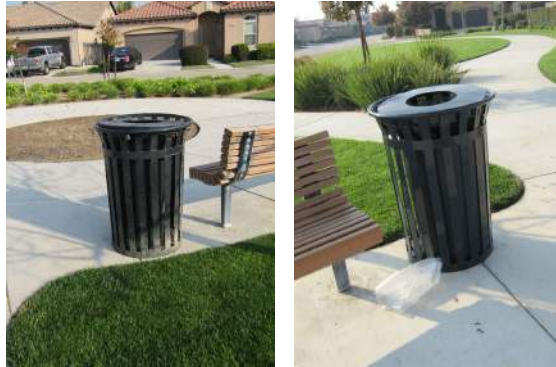
Trash Receptacle continued...

This component is for the Cassidy style trash receptacle located in the park. It appeared to be in good condition.

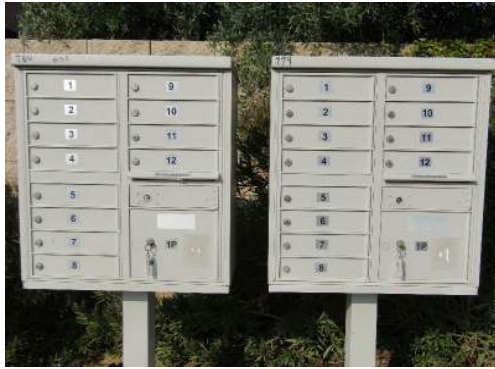
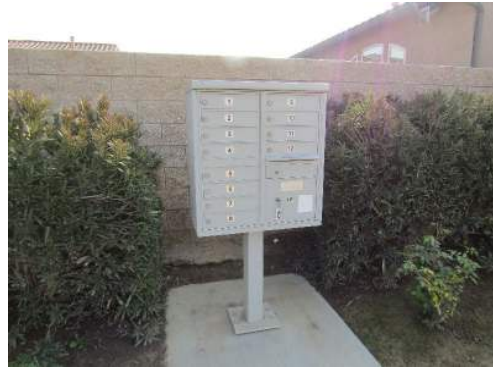
This is to replace the mailbox clusters containing 12 boxes, 1 parcel box, and a drop box (14 doors total). Locks and hinges should be lubricated seasonally, as needed. At the time of inspection, the mailboxes appeared to be in good condition, with typical signs of aging but no sign of minor surface rust, dents, excessive wear, warping, or vandalism.

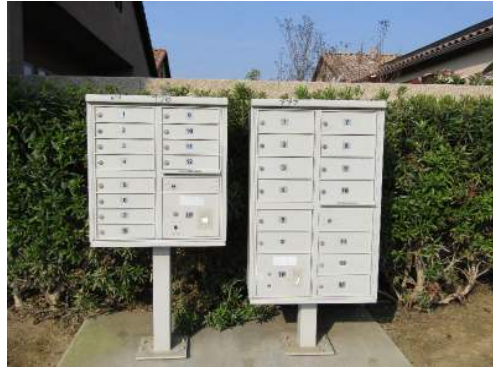
Cluster Mailboxes - 13 Units continued...

This is to replace the mailbox clusters containing 13 boxes, 1 parcel box, and a drop box (15 doors total). Locks and hinges should be lubricated seasonally, as needed. At the time of inspection, the mailboxes appeared to be in good condition, with typical signs of aging but no sign of minor surface rust, dents, excessive wear, warping, or vandalism.

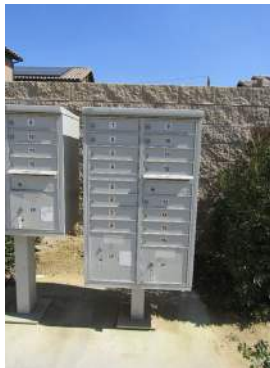
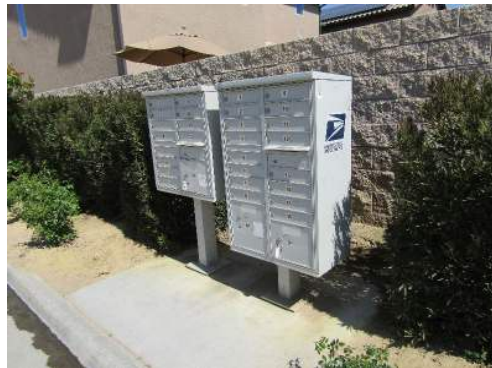
This is to replace the mailbox clusters containing 16 boxes, 2 parcel boxes, and a drop box (19 doors total). Locks and hinges should be lubricated seasonally, as needed. At the time of inspection, the mailboxes appeared to be in good condition, with typical signs of aging but no

sign of minor surface rust, dents, excessive wear, warping, or vandalism.

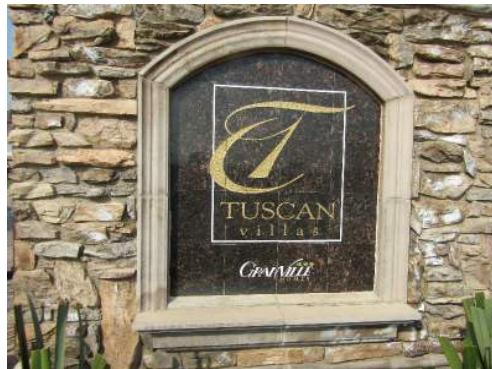
This component covers the replacement of the granite monument sign located at the Fowler Avenue entry. It appeared to be in good condition with no sign of damage. Efflorescence is noted on the stone surrounding the sign. This has been addressed within another component.

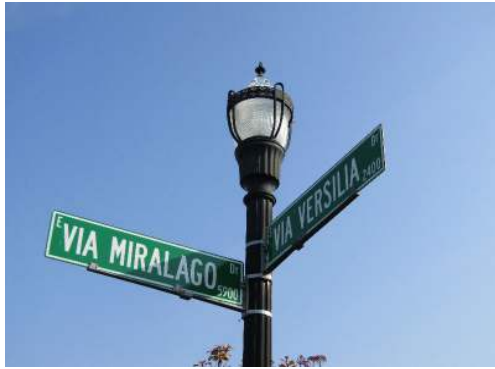
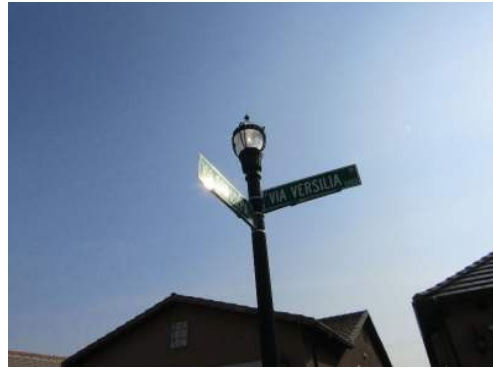
This component covers the replacement of the street signs throughout the development. They appeared to be in good condition.
