RESERVE ANALYSIS REPORT

CBS Sample Owners Association

Full Study with Site Visit

February 5, 2022

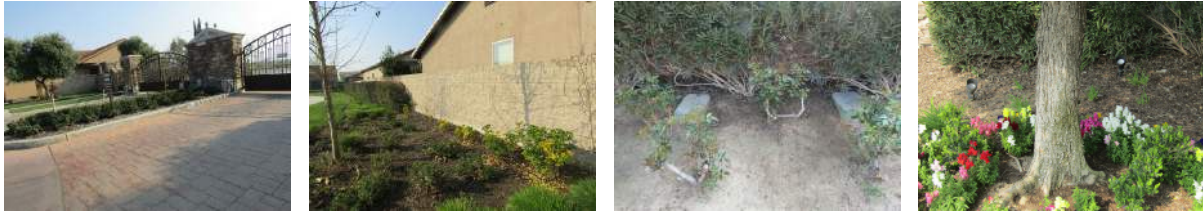
Landscape Replenishment continued...

This component is for the replacement and replenishment of the landscaping. This landscaping includes many types of plants and trees throughout the development. All of the different landscape items will have different life expectancies. This is an average estimate which may vary based on climate, drought conditions, damage from animals, etc. Pruning, trimming, and other maintenance is handled operationally. The most recent records indicate that \$425.00 was spent for new tree roses at the front entrance.

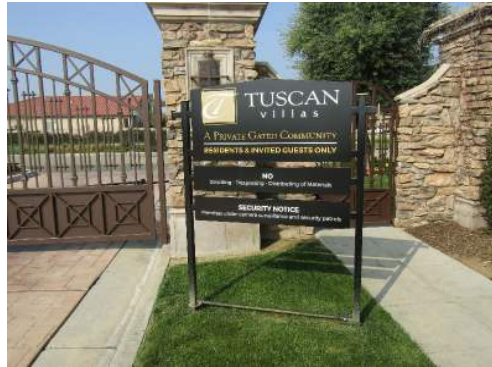
This component is for the replacement of the custom sign at the entry on Fowler Avenue. Records indicate the sign was manufactured and installed in June, 2016.

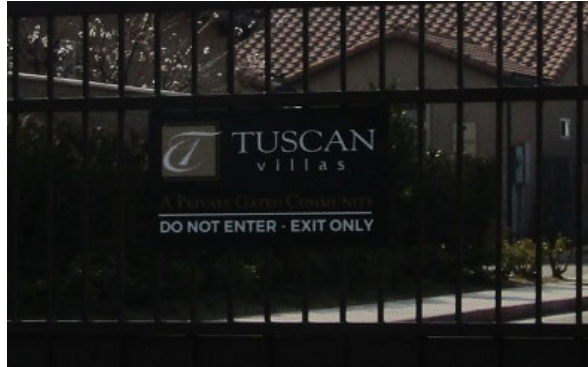
Exit Sign continued...

This component is for the replacement of the custom sign at the exit on Church Avenue. Records indicate the sign was manufactured and installed in June, 2016.
